Limited Veneer Stability Assessment
138-188 Delaware Avenue, Troy, NY

JUNE 23, 2023

PROJECT NO. CZ321AW.14

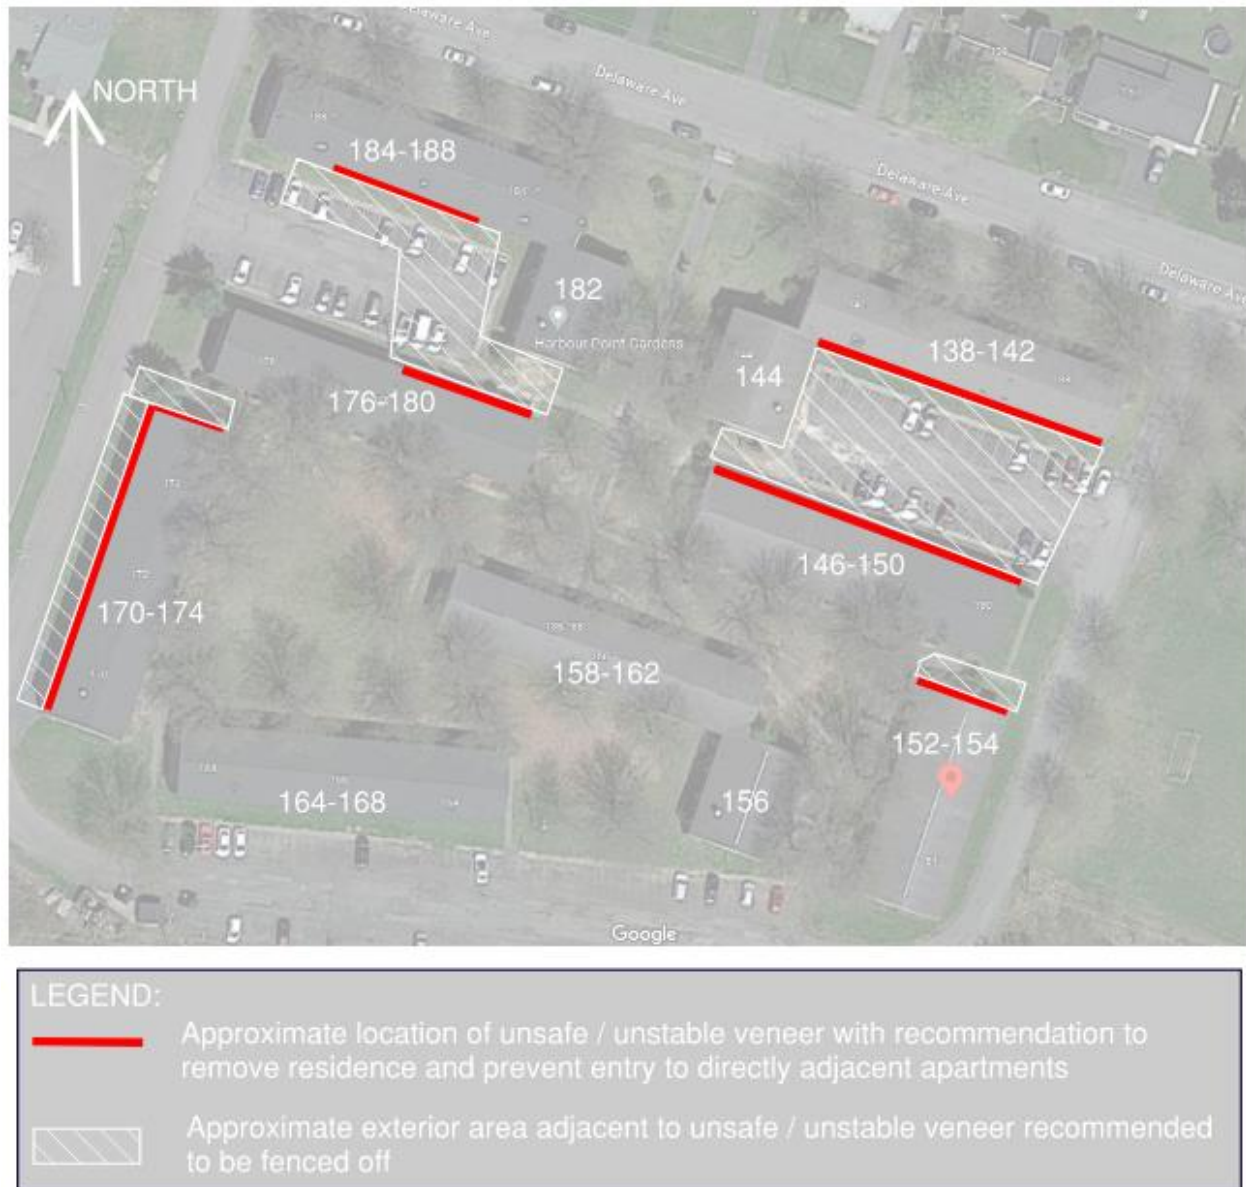
Figure 1: Aerial View of the Project Site
(Aerial Photograph taken from google.com/maps)

Reference Appendix A Photographs 1 through 10 for views of the brick veneer conditions. Multiple veneers are bowing out creating unsafe / unstable conditions. Figure 1 identifies specific locations that are unsafe due to unstable brick veneers.

1. Remove occupants from apartment units in direct contact with veneers deemed unsafe / unstable identified in Figure 1.
2. Provide barriers such as construction fencing within 10 feet of unsafe / unstable veneers. These areas have been identified in Figure 1.
3. Remove unstable / unsafe veneers, and provide temporary exterior weather barrier.

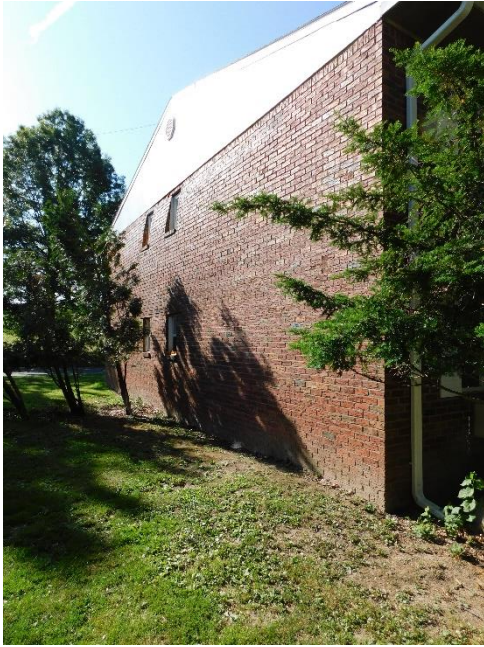
Photograph (1):

View of northeast wall of building 152-154.
Note the brick veneer is bowing and measured to be more than 3 inches out of plumb.

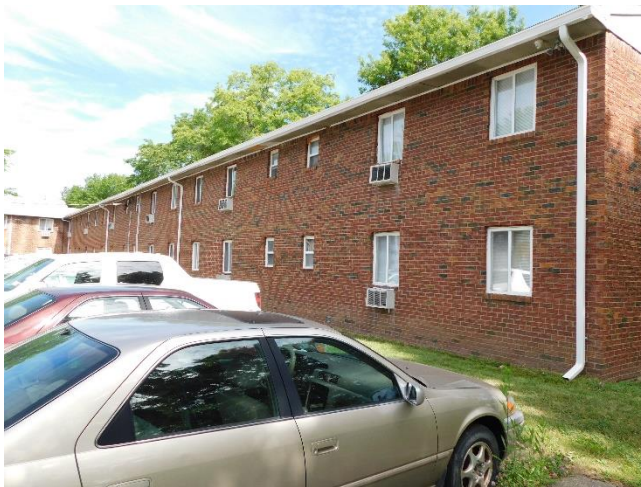
Photograph (2):

View of southwest wall of building 138-142.
Note the brick veneer is bowing and measured to be more than 3 inches out of plumb.

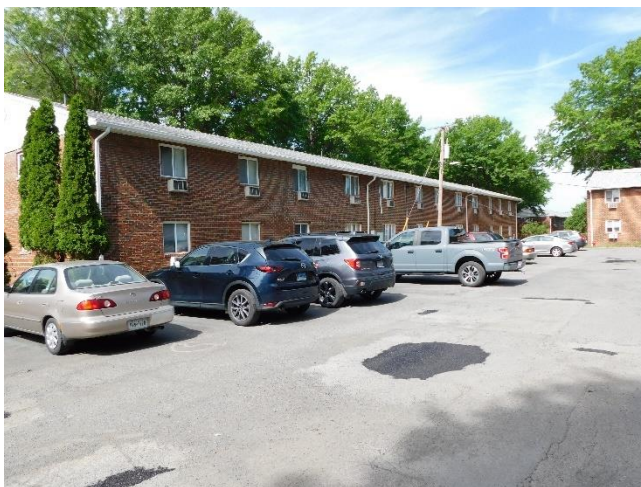
Photograph (3):

View of northeast wall of building 146-150.
Note the brick veneer is bowing and measured to be more than 3 inches out of plumb.

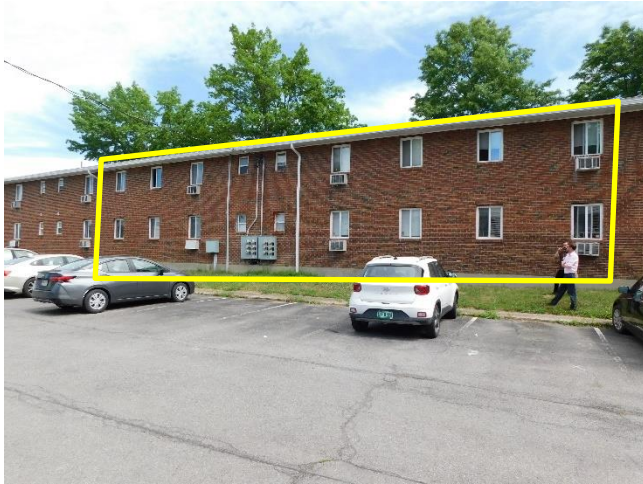
Photograph (4):

View of southwest wall of building 184-188. Note the brick veneer is bowing and observed to be more than 2 inches out of plumb within the yellow outlined region.

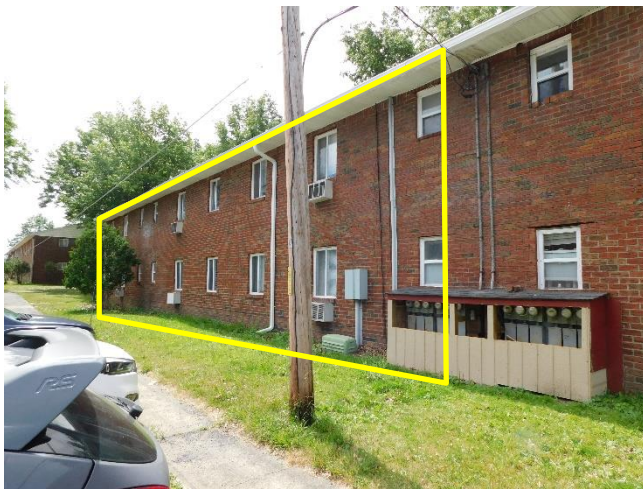
Photograph (5):

View of northeast wall of building 176-180. Note the brick veneer is bowing and observed to be more than 2 inches out of plumb within the yellow outlined region.

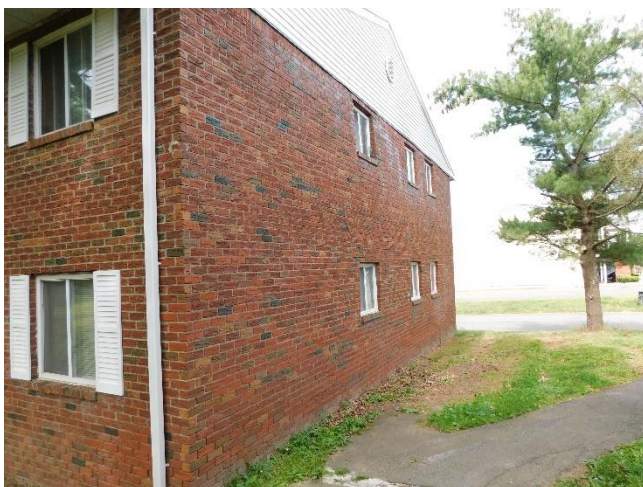
Photograph (6):

View of northeast wall of building 170-174. Note the brick veneer is bowing and observed to be more than 2 inches out of plumb.

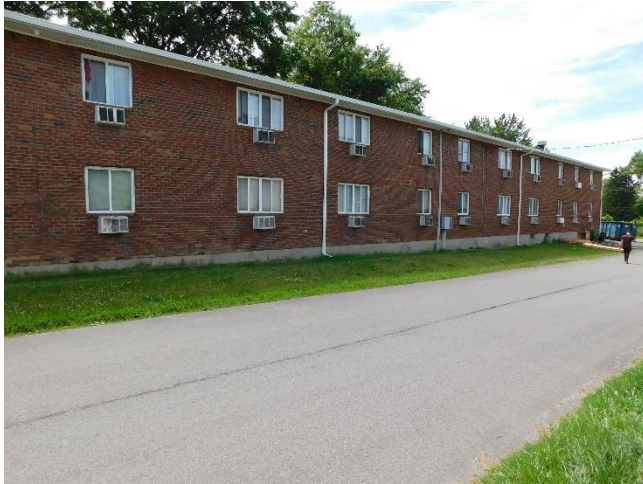
Photograph (7):

View of northwest wall of building 170-174. Note the brick veneer is bowing and observed to be more than 2 inches out of plumb.

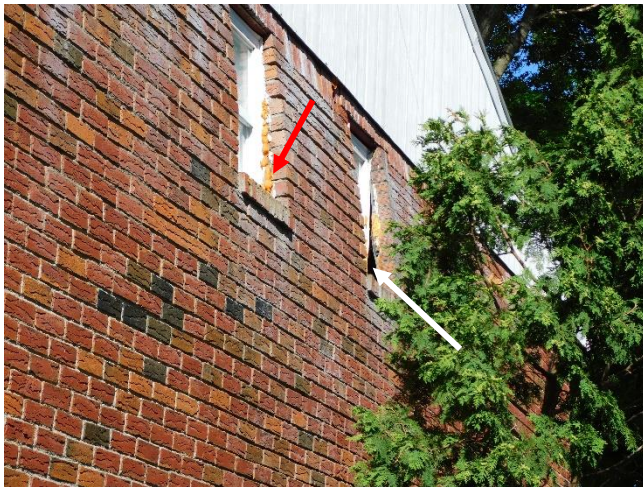
Photograph (8):

View of second story windows along the northeast wall of building 152-154. Note the veneer has separated from the window creating an opening (white arrow) in the building envelope. Note the orange spray foam (red arrow) previously installed around the windows to infill this gap.

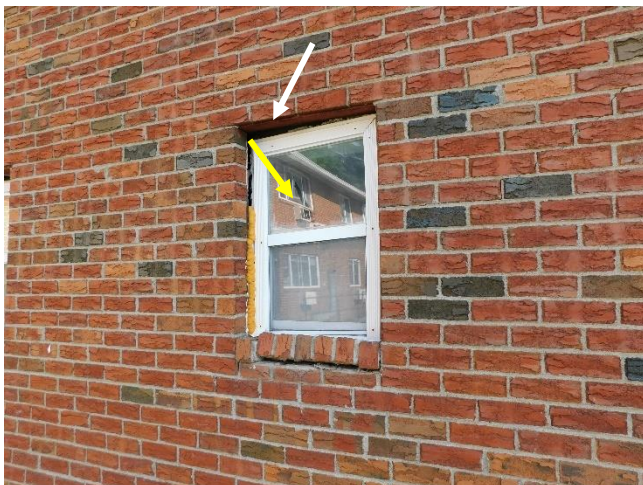
Photograph (9):

View of window located along southwest elevation of building 138-142. Note the window is broken (yellow arrow), there is a gap between the window and the veneer (white arrow), and the sill bricks are loose.

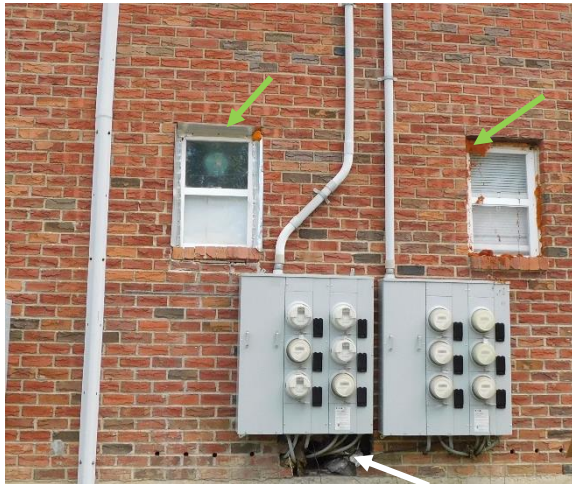
Photograph (10):

View of windows and electrical service connections at the southwest elevation of building 184-188. Note the orange spray foam (green arrow) and the aluminum thresholds (green arrow) installed to cover the gap between the window and the veneer. Note the opening (white arrow) in the veneer at the electrical service connection.

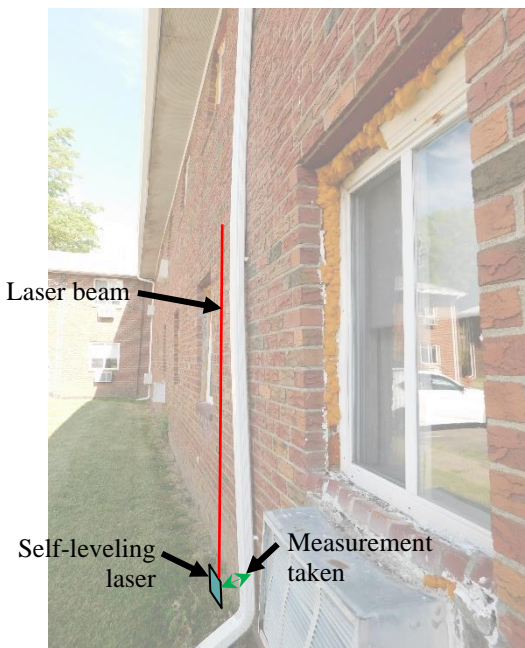
Photograph (12):

Veneer eccentricities were measured at multiple locations within the project site using a self-leveling laser located at ground level to points approximately 7' to 9' above grade. The measurements taken indicated more than 3 inches out of plumb. Reference Photograph 12 for an example of measurement. Based on these measurements, the veneers are being engaged by secondary failure modes currently preventing imminent collapse.

Example laser measurement diagram. Reference Photograph 11 for view of self-leveling laser.
